1. PURPOSE/SCOPE OF REPORT

During the spring of 2010, the arsenic treatment system at Well 4 had several instances where the finished water exceeded the Maximum Contaminant Level (MCL) of arsenic at 10 µg/L (ppb). The New Mexico Environment Department (NMED) issued official Notices of Violation to Bernalillo on two occasions, one each for wells 3 and 4, and the agency required a corrective plan to be developed. Thus, the Town of Bernalillo implemented a Corrective Action Plan (CAP) that was proposed to and accepted by NMED for investigations and corrective actions at the water treatment facilities of Wells 3 & 4.

The purpose of this report is to summarize the CAP and the results of the investigations, and to make recommendations for improvements to the water treatment system especially pertaining to the arsenic treatment facilities. This report will include the following components:

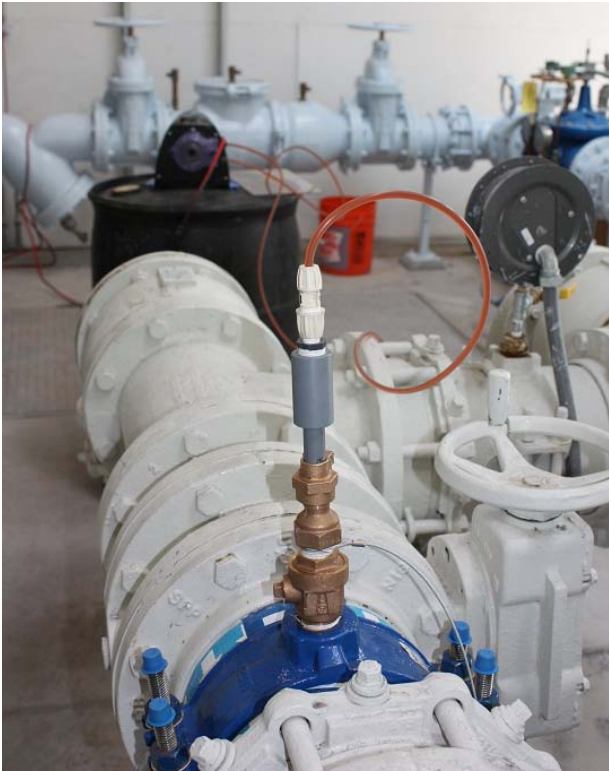
Corrective measures were started following approval of the CAP by NMED on March 29, 2010. The first of which was to augment the electro-flocculation system with ferric chloride to act as a coagulant for removing arsenic. The ferric chloride was injected using a chemical metering pump into the untreated well water. The methodology for improving arsenic removal was to gradually increase the dose of ferric chloride while reducing the amperage of the electro-flocculation system. The dosage of ferric chloride and the electro-flocculation amperage for well 4 investigations is presented in Table 1. A picture of the ferric chloride injection port and pump at well 4 is shown in Figure 1.

Figure 1: Ferric Chloride Injection Port and Pump at Well 4

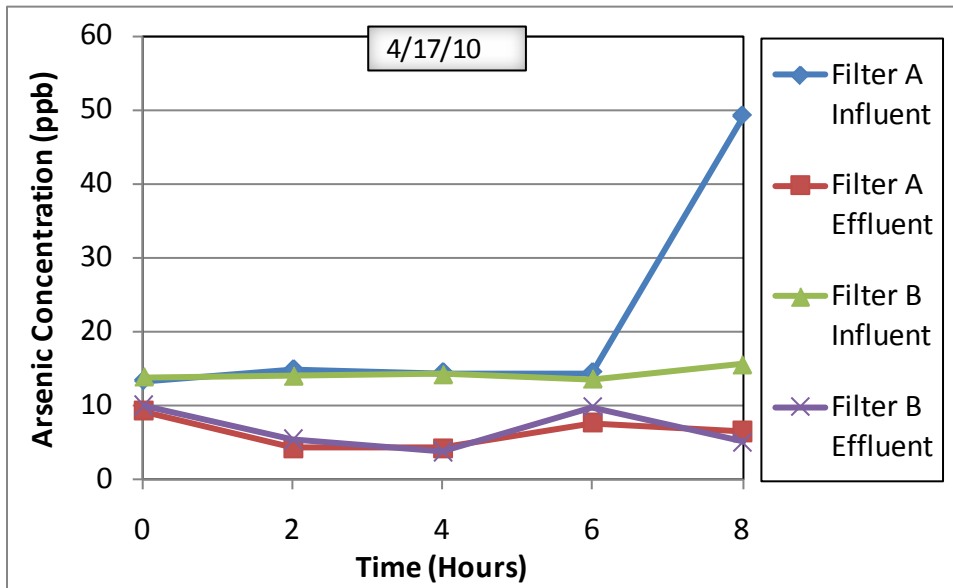
The first water testing event was carried out by WCI on April 17th using stage 1 conditions from Table 1. The arsenic, iron, and aluminum concentrations for the filter influent and effluent over time are shown in Figure 2, Figure 3, and Figure 4, respectively. Arsenic concentrations were reduced from 12.4 ppb to between 4.2 and 10 ppb with an average concentration of 6.6 ppb. After blending 1:1, the arsenic concentration would be about 9.5 ppb. Interestingly, iron concentrations were tightly correlated with arsenic concentrations in the influent water to the pressure filters. Iron was not consistently removed by the pressure filters to concentrations below the maximum contaminant level (MCL) standard of 0.3 ppb. Aluminum concentrations were higher than the MCL standards and were similar in the influent to and the effluent from both pressure filters. A sharp spike occurred in both the iron and arsenic influent concentrations at the end of the testing while backwash water decant was used.

Figure 2: Arsenic Concentration over time for 4/17 Run with Electro-flocculation set at 130 amps and a Ferric Chloride dose of 1.89 mg/L

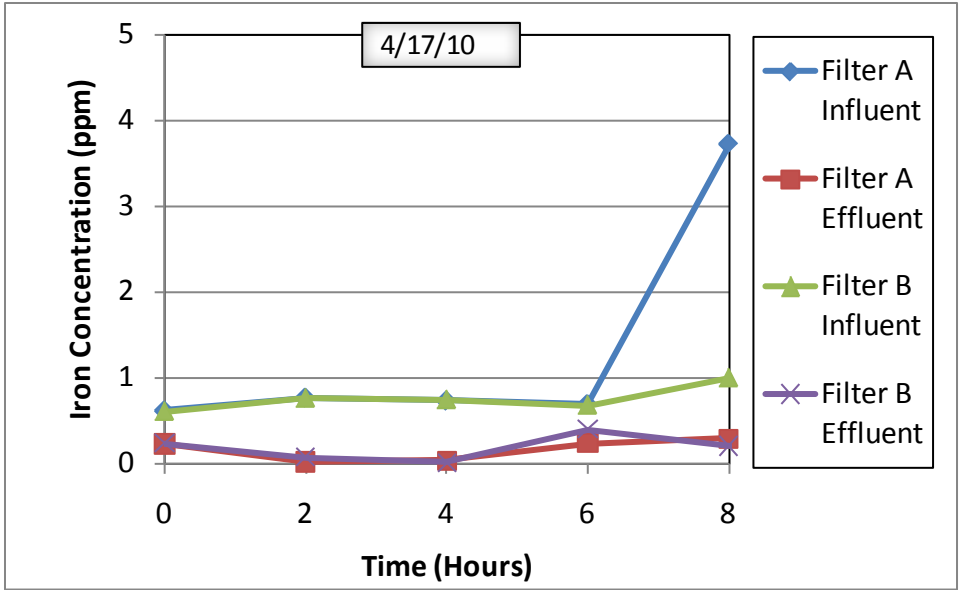
Figure 3: Iron Concentration over time for 4/17 Run with Electro-flocculation set at 130 amps and a Ferric Chloride dose of 1.89 mg/L

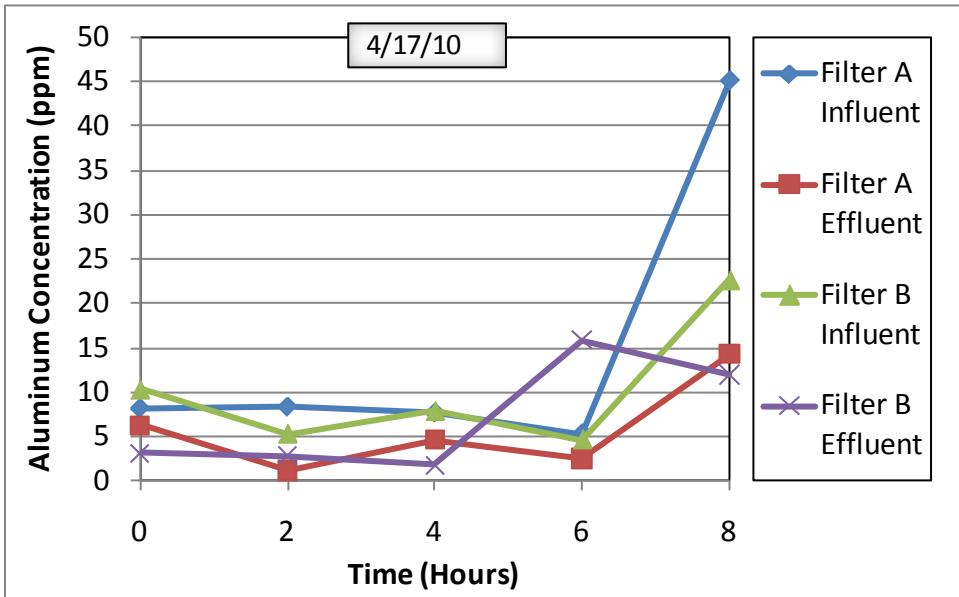
Figure 4: Aluminum Concentration over time for 4/17 Run with Electro-flocculation set at 130 amps and a Ferric Chloride dose of 1.89 mg/L

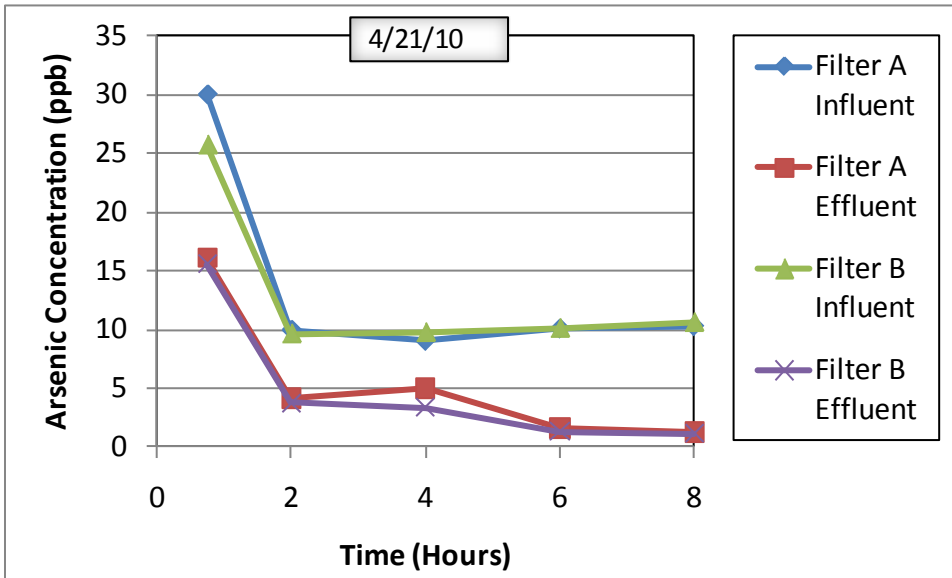
The second water testing event was conducted on April 21st using stage 2 conditions from Table 1. The arsenic, iron, and aluminum concentrations for the filter influent and effluent over time are shown in Figure 5, Figure 6, and Figure 7, respectively. The arsenic concentrations in the filter effluent ranged between 1.15 and 16.1 ppb with an average concentration of 5.3 ppb. As in the previous test, a tight correlation was observed between the influent iron and arsenic concentrations. The sharp spike in both iron and arsenic concentrations at the beginning of the test occurred when backwash decant water was being used. Aluminum concentrations were observed above MCL standards, but were on average approximately 50% lower than the previous test at 130 amps and 1.9 mg/L ferric chloride. Three of the effluent water samples had iron concentrations surpassing the MCL standard.

Figure 5: Arsenic Concentration over time for 4/21 Run with Electro-flocculation set at 10 amps and a Ferric Chloride dose of 4.5 mg/L

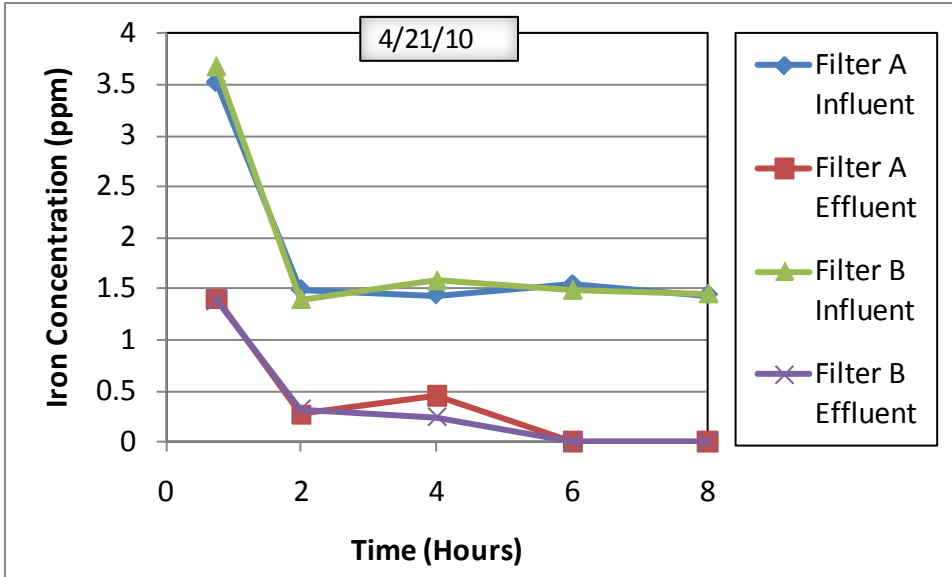
Figure 6: Iron Concentration over time for 4/21 Run with Electro-flocculation set at 10 amps and a Ferric Chloride dose of 4.5 mg/L

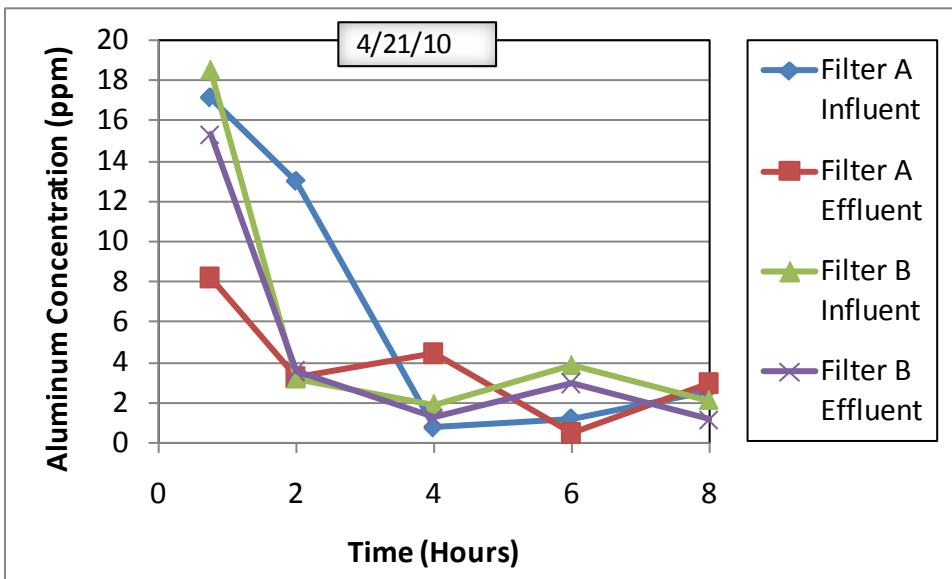
Figure 7: Aluminum Concentration over time for 4/21 Run with Electro-flocculation set at 10 amps and a Ferric Chloride dose of 4.5 mg/L

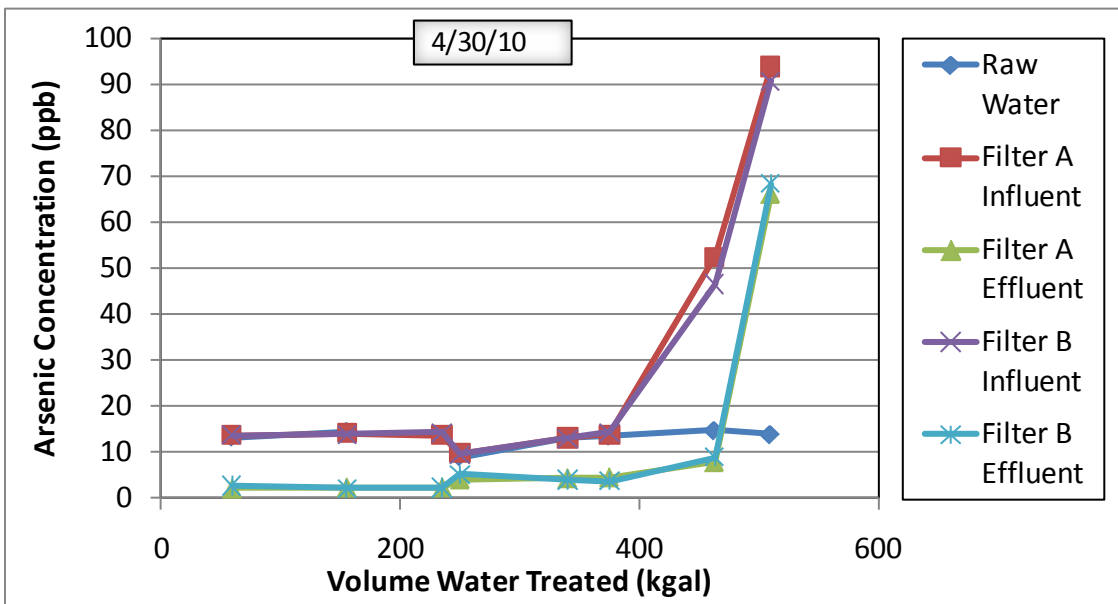
concentrations for the raw water, filter influent and effluent over volume of water treated are shown in Figure 8, Figure 9, and Figure 10, respectively. Effluent water iron and arsenic concentrations remained below MCL standards until after 450,000 gal treated. Sporadic peaks in aluminum concentration occurred throughout the filter run. These instances of high aluminum concentrations were likely due to residual aluminum hydroxide sloughing off of either the electro-flocculation tanks and/or the piping. After 450,000 gallons treated, spikes in arsenic, iron, and aluminum concentrations were observed in both the filter influent and effluent. These large spikes occurred when backwash decant water was first introduced into the system, as had transpired previously. Because there was never an increase in effluent arsenic and iron concentrations without a corresponding increase in influent iron and arsenic concentrations, filter breakthrough was not shown to have occurred.

Figure 8: Arsenic Concentration over time for 4/30 Run with no Electro-flocculation and a Ferric Chloride dose of 3.2 mg/L

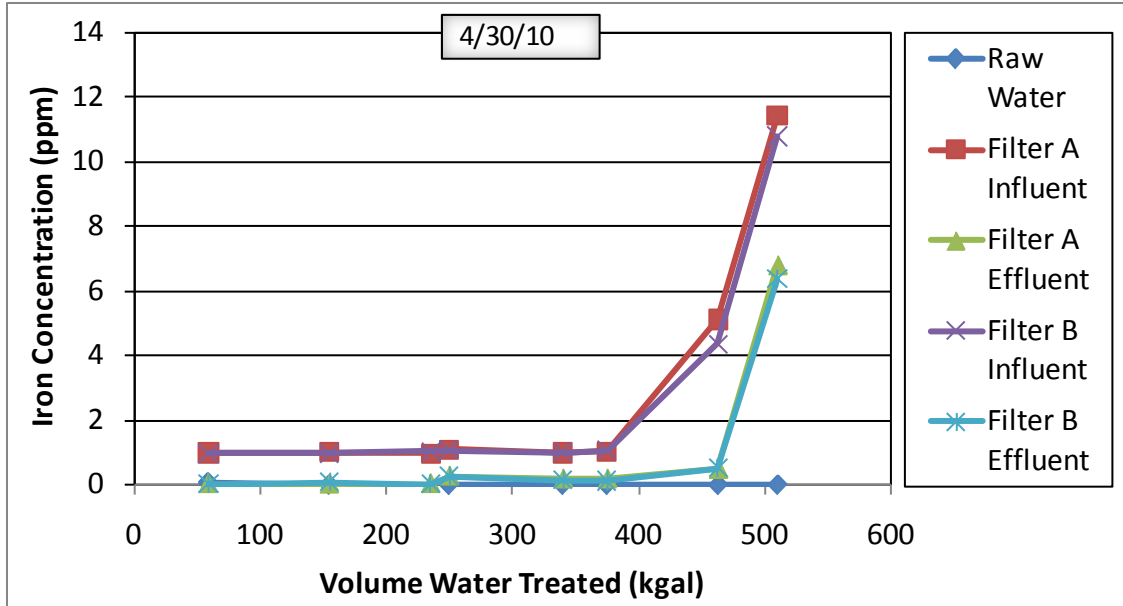
Figure 9: Iron Concentration over time for 4/30 Run with no Electro-flocculation and a Ferric Chloride dose of 3.2 mg/L

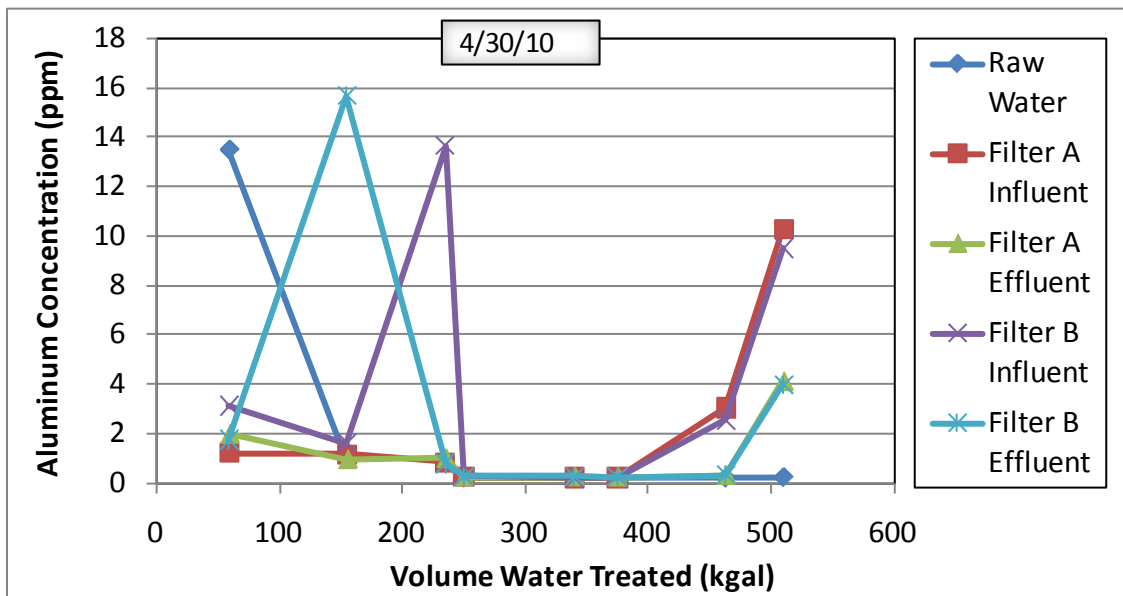
Figure 10: Aluminum Concentration over time for 4/30 Run with no Electro-flocculation and a Ferric Chloride dose of 3.2 mg/L

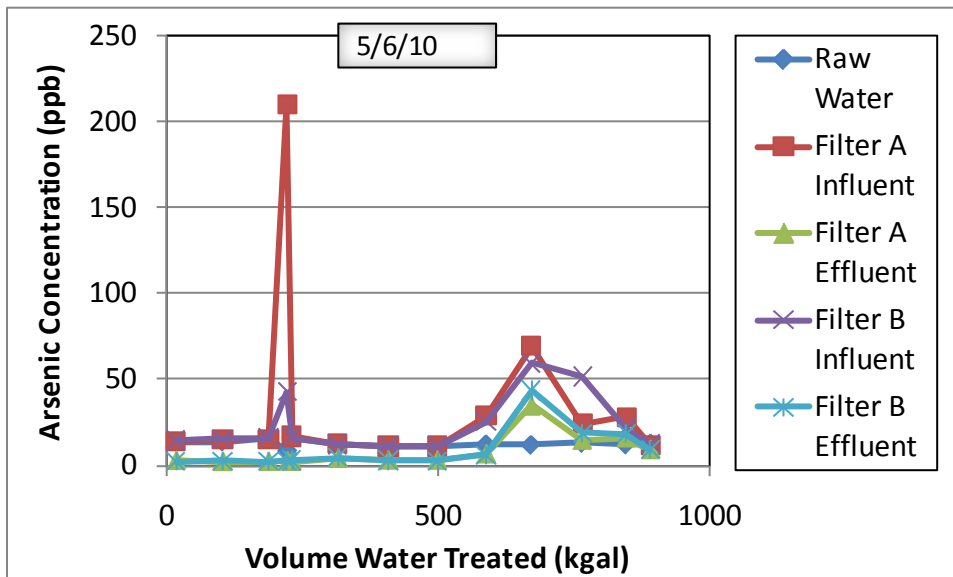
Figure 12, and Figure 13, respectively. A large spike in arsenic and iron concentrations was measured in the filter influent water, but not in the raw water after 222,000 gallons treated. This corresponded with the introduction of backwash decant water to the system. Another smaller spike in influent iron and arsenic concentration occurred after 600,000 gallons treated. A larger spike was observed in aluminum concentration over this same period. An increase in the pressure drop across the filters was recorded concurrently with a measured increase in arsenic, iron, and aluminum concentrations, indicating filter breakthrough. Due to the consistency in correlation between increased arsenic, iron, and aluminum concentrations in the influent and effluent water samples and backwash decant water use, large concentrations of these metals were suspected in the backwash decant water. Therefore, backwash decant water samples were collected and analyzed along with the influent, effluent, and raw water samples at each time point. Results showed, as expected, that the backwash decant water was many times more concentrated than the raw water in terms of arsenic, iron, and aluminum concentration, especially when first being used in each filter run. One backwash decant water sample had concentrations of 191 ppm iron, 1915 ppb arsenic, and 34 ppm aluminum. Relative to the NMED MCL regulations, that is 637 times greater iron, 192 times greater arsenic, and 113 times greater aluminum.

Figure 11: Arsenic Concentration over time for 5/6 Run with no Electro-flocculation and a Ferric Chloride dose of 3.2 mg/L

prompted an investigation of the plant operations, which involved a review of the available plant schematics and discussions with the plant operators. The valve to the bottom of the backwash tank which allowed the settled floc, or sludge, to be pumped to the Sludge Mate trailers for solids disposal was always left open. The valve that allowed the decant water to be gravity fed to a sump inside of the plant which allowed the backwash decant water to be reintroduced to the system was only opened during sludge removal, but closed during normal operations. Thus, the sludge and the decant water were being collected into the Sludge Mate trailers for solids disposal, but only the sludge, and not the decant water, was being reintroduced to the system once the floc had been allowed to settle. This issue was corrected, the plant operators were informed of correct operating procedures with regards this issue, and a protocol was written for operations instruction so the issue would not recur. The sludge removal procedure and process diagram are shown in the appendix. After the plant was operated correctly for one week, another water testing was undertaken at the same ferric dose as the last water testing run, as described below. Removal of the backwash water was thus no longer considered necessary.

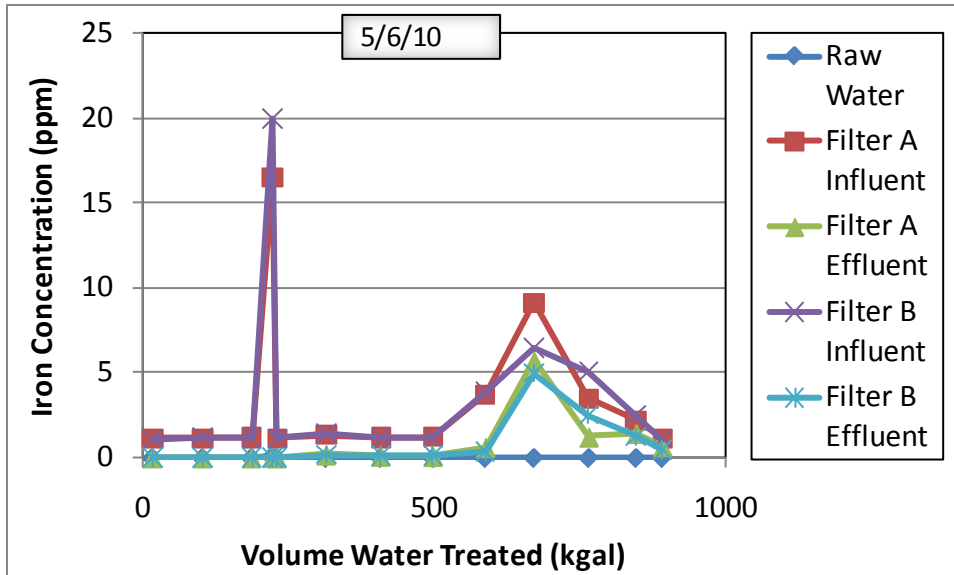
Figure 12: Iron Concentration over time for 5/6 Run with no Electro-flocculation and a Ferric Chloride dose of 3.2 mg/L

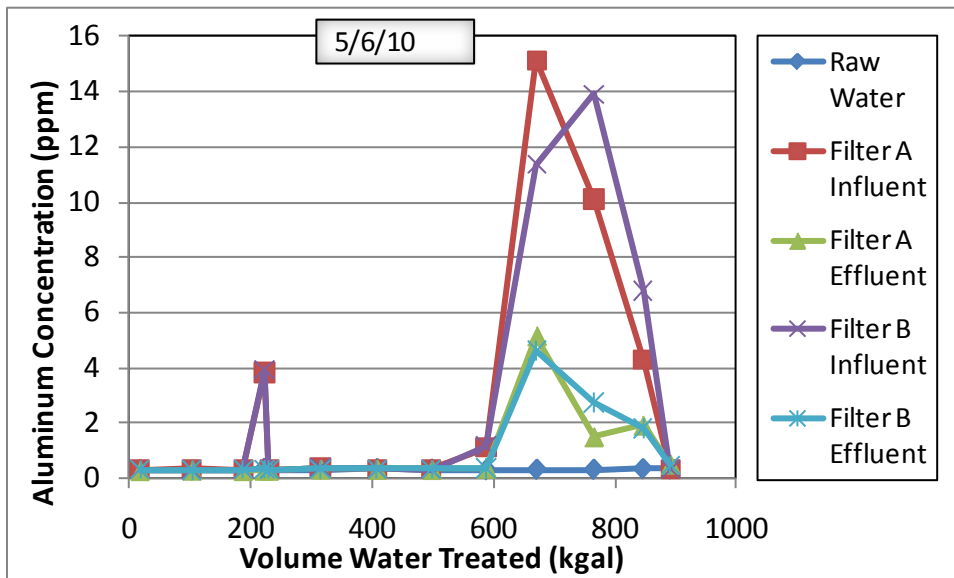
Figure 13: Aluminum Concentration over time for 5/6 Run with no Electro-flocculation and a Ferric Chloride dose of 3.2 mg/L

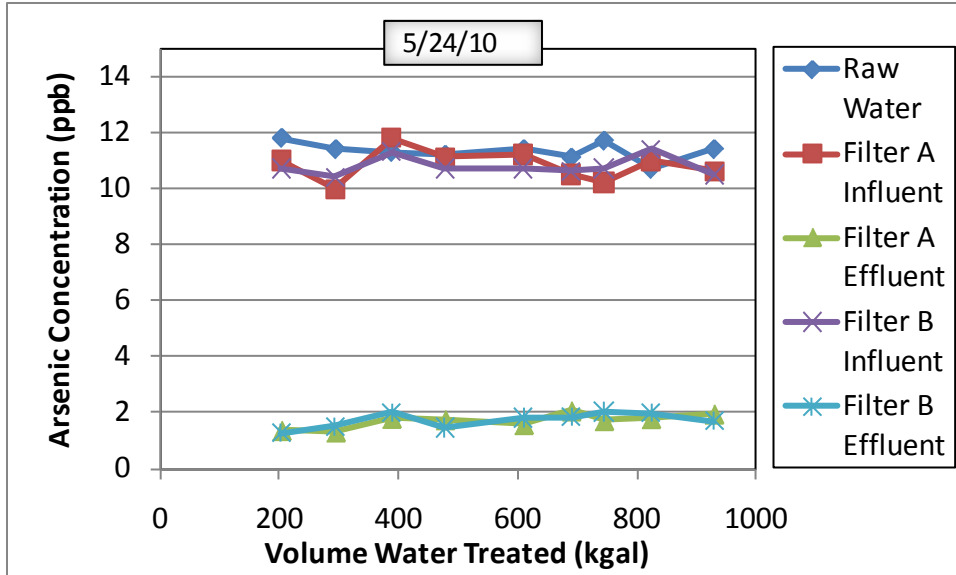
Once backwash operations were corrected, the fifth water testing event was conducted on May 24th using stage 5 conditions from Table 1. The arsenic, iron, and aluminum concentrations for the raw water, filter influent and effluent over volume of water treated are shown in Figure 14, Figure 15, and Figure 16, respectively. Effluent iron concentrations were always below the detection limit. Effluent arsenic was consistently reduced to between 1.3 and 2.1 ppb with an average of 1.7 ppb. Aluminum concentrations were below the MCL, averaging 0.12 ppm. After blending, the arsenic concentration was about 7.1 ppb, which is well below the MCL of 10 ppb. Even after 900,000 gallons treated, filter breakthrough did not occur nor had the differential pressure across the filter (programming set at 10 psi) been exceeded.

Figure 14: Arsenic Concentration over time for 5/24 Run with no Electro-flocculation and a Ferric Chloride dose of 3.2 mg/L

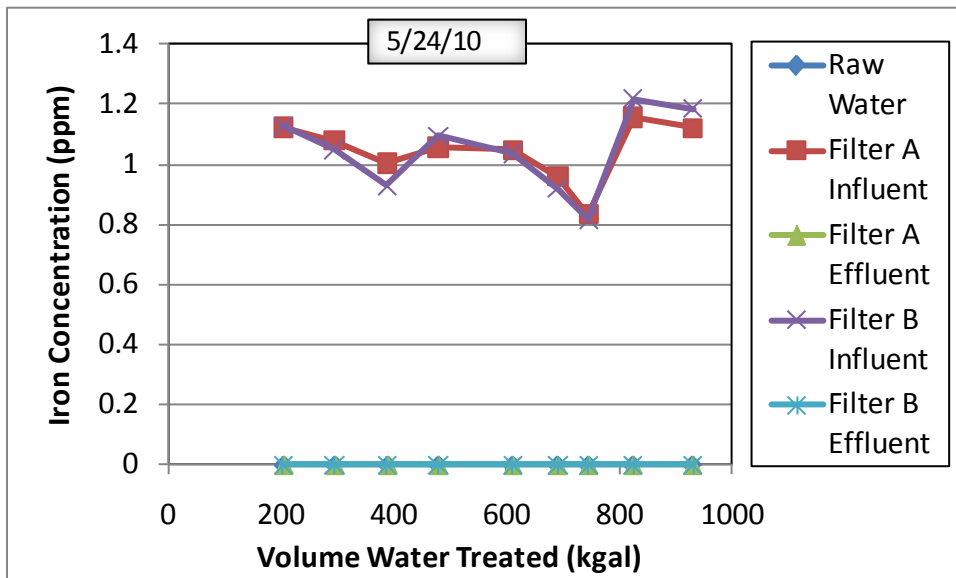
Figure 15: Iron Concentration over time for 5/24 Run with no Electro-flocculation and a Ferric Chloride dose of 3.2 mg/L

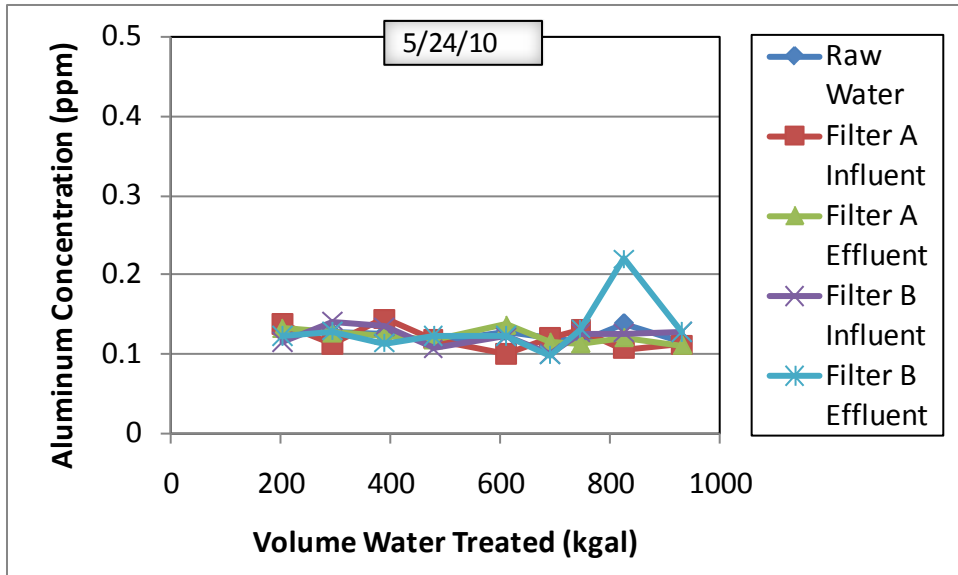
Figure 16: Aluminum Concentration over time for 5/24 Run with no Electro-flocculation and a Ferric Chloride dose of 3.2 mg/L

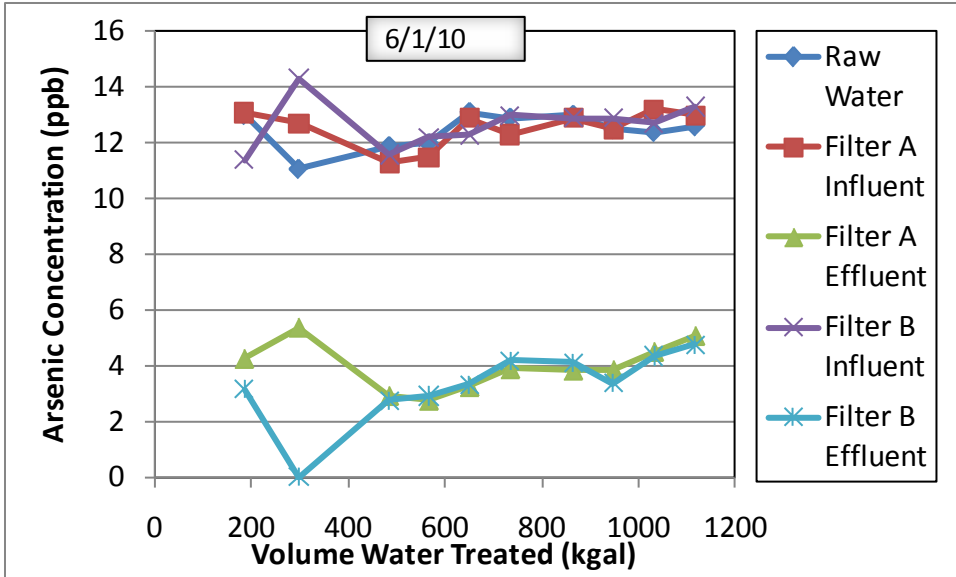
The sixth water testing event was on June 1st using stage 6 conditions from Table 1. The arsenic, iron, and aluminum concentrations for the raw water, filter influent and effluent over volume of water treated are shown in Figure 17, Figure 18, and Figure 19, respectively. Effluent arsenic concentrations ranged from 2.8 to 5.4 ppb, with an average of 3.7 ppb. Effluent iron concentrations remained below the detection limit. Aluminum concentrations were consistently below 0.2ppm, which is safely below the secondary limit. What aluminum was within the system was not a part of the treatment operation since the Electro-flocculation system had been turned off for several months. During the 1.1 million gallon filter run, filter breakthrough did not appear to have occurred.

Figure 17: Arsenic Concentration over time for 6/1 Run with no Electro-flocculation and a Ferric Chloride dose of 2.5 mg/L

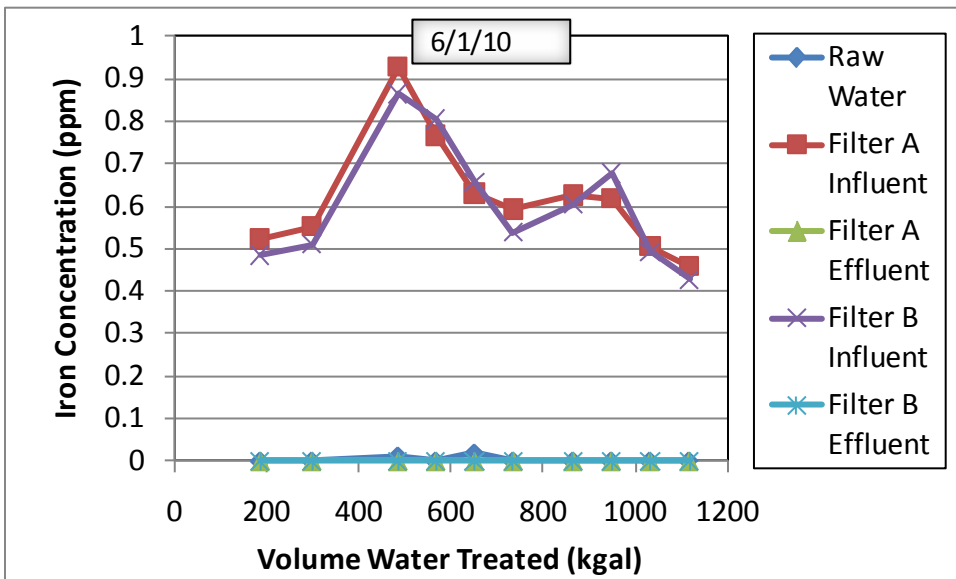
Figure 18: Iron Concentration over time for 6/1 Run with no Electro-flocculation and a Ferric Chloride dose of 2.5 mg/L

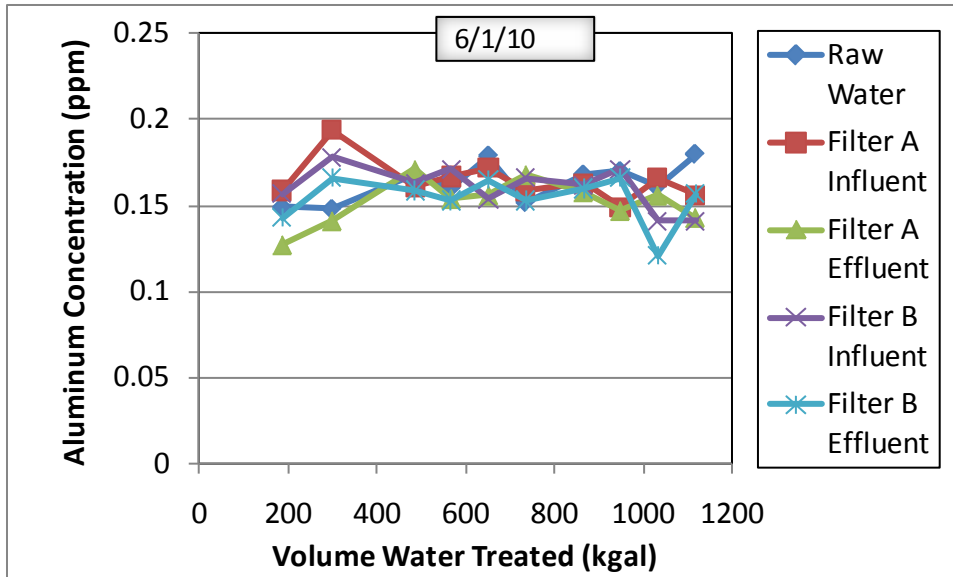
Figure 19: Aluminum Concentration over volume of treated water for 6/1 Run with no Electro-flocculation and a Ferric Chloride dose of 2.5 mg/L

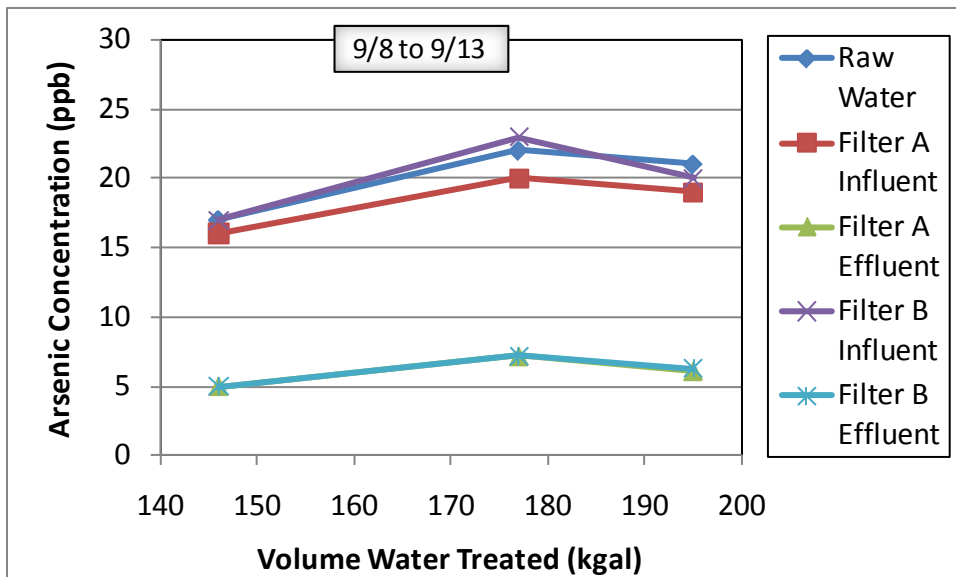
turned on for testing, 95,000 gallons of well water had been treated since the previous backwash. Well 3 was run for a total of 8 hours, during which 100,000 gallons were treated and three sets of samples were collected for analysis. The arsenic, iron, and aluminum concentrations for these samples are presented in **Figure 20**, **Figure 21**, and **Figure 22**, respectively. The average arsenic concentration in the raw water was 20 ppb. After ferric chloride treatment, the arsenic concentration was brought below 10 ppb, with an average of 6.1 ppb. Iron was effectively removed from the ferric chloride treated influent water by the pressure filters to levels near the raw water concentration and below the limit of 0.3 ppm. Aluminum concentrations were consistently lower than the 0.2 mg/L (ppm) limit, and were never measured above 0.01 ppm. However, the aluminum concentrations in the influent and effluent samples were typically higher than the raw water concentrations, for one sample, even three times the concentration of the raw water. This indicates that some of the aluminum previously deposited in the system is being reintroduced into the treated water.

Figure 20: Arsenic Concentrations over Volume of Water Treated for September 8th through 13th with a Ferric Chloride dose of 2.9 mg/L

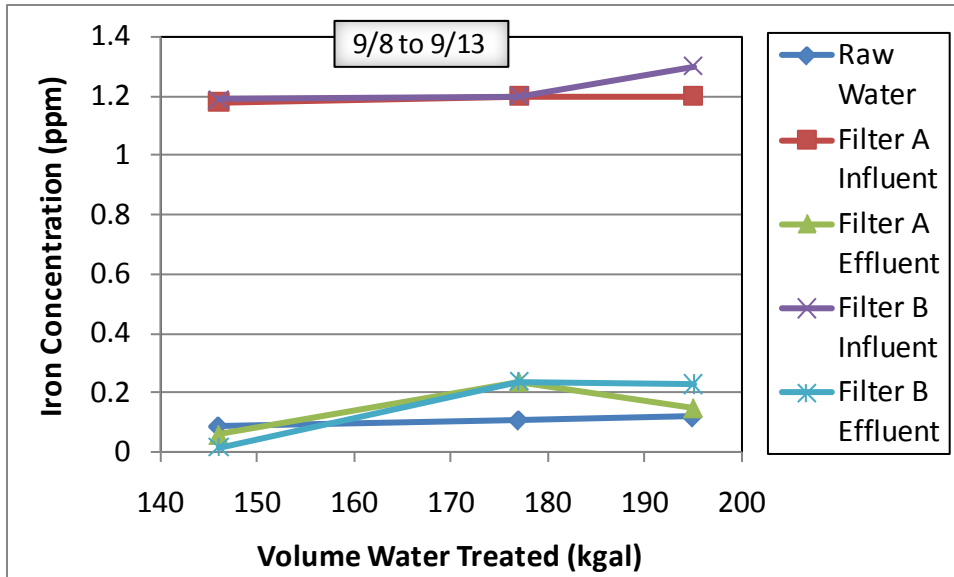
Figure 21: Iron Concentration over Volume of Water Treated for September 8th through 13th with a Ferric Chloride dose of 2.9 mg/L

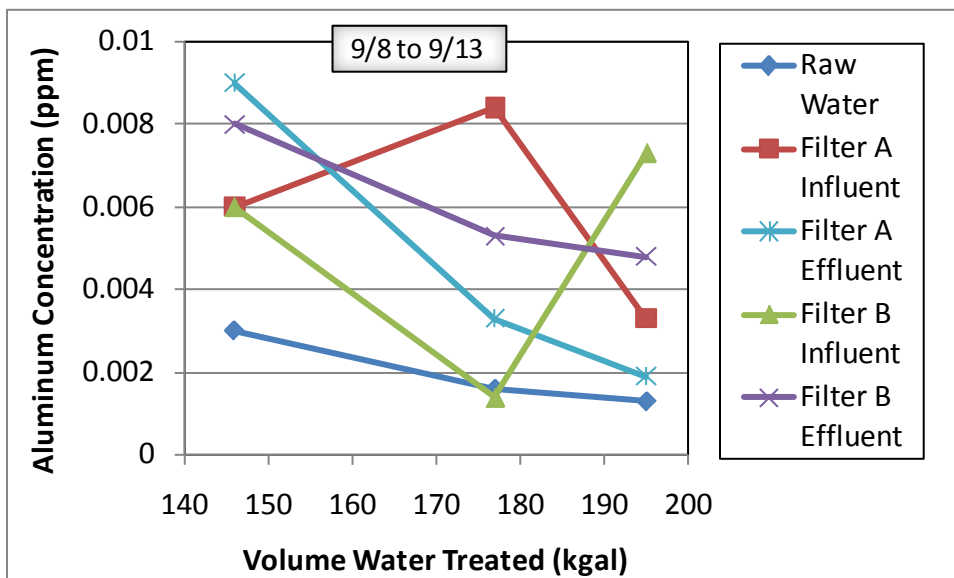
Figure 22: Aluminum Concentration over Volume of Water Treated for September 8th through 13th with a Ferric Chloride dose of 2.9 mg/L

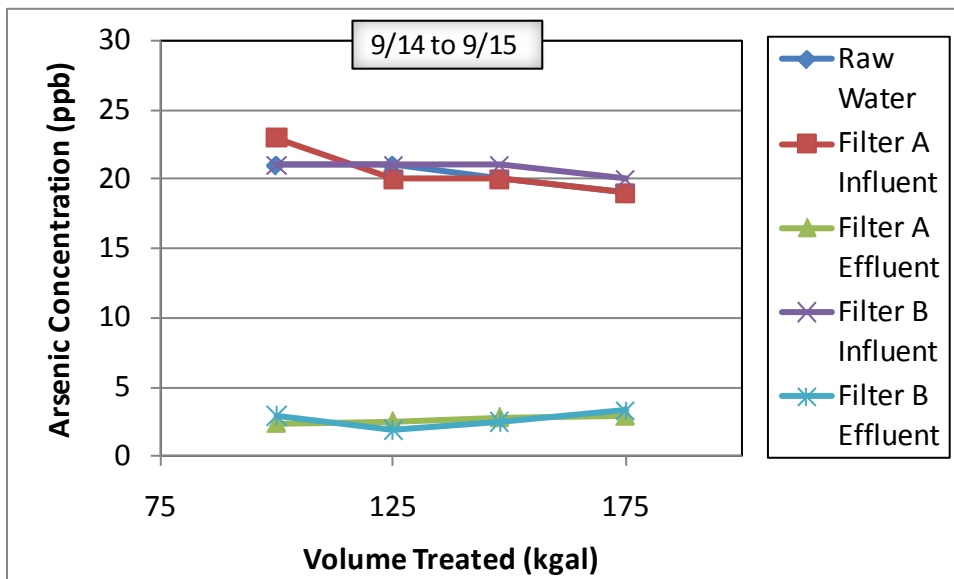
September 14th, and again on Wednesday September 15th. When initially turned on for testing, 7,000 gallons of well water had been treated since the previous backwash, according to the total volume treated display. Well 3 was run for a total of 10.5 hours, during which 168,000 gallons were treated, according to the total volume treated display, and four sets of samples were collected for analysis. The arsenic, iron, and aluminum concentrations for these samples are presented in **Figure 23**, **Figure 24**, and **Figure 25**, respectively. The average arsenic concentration in the raw water was 20 ppb. After ferric chloride treatment, the arsenic concentration was brought below 10 ppb, with an average of 2.7 ppb. Iron was effectively removed from the ferric chloride treated influent water by the pressure filters to levels below the raw water concentration and below 0.1 ppm, which is 30 percent lower than the iron concentration limit of 0.3 ppm. Aluminum concentrations were consistently lower than the 0.2 ppm limit, and were never measured above 0.03 ppm.

Figure 23: Arsenic Concentrations over Volume of Water Treated for September 14th through 15th with a Ferric Chloride Dose of 3.5 mg/L

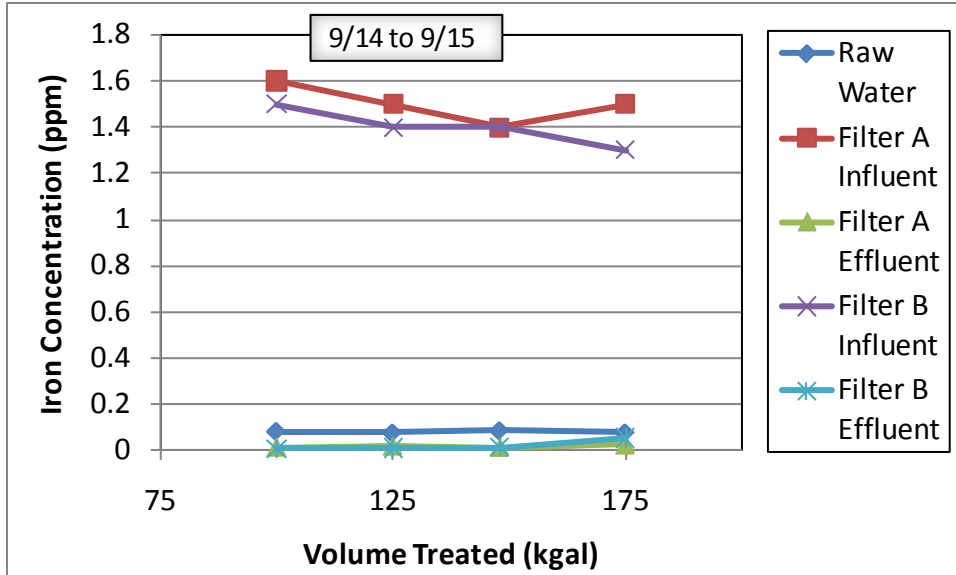
Figure 24: Iron Concentrations over Volume of Water Treated for September 14th through 15th with a Ferric Chloride dose of 3.5 mg/L

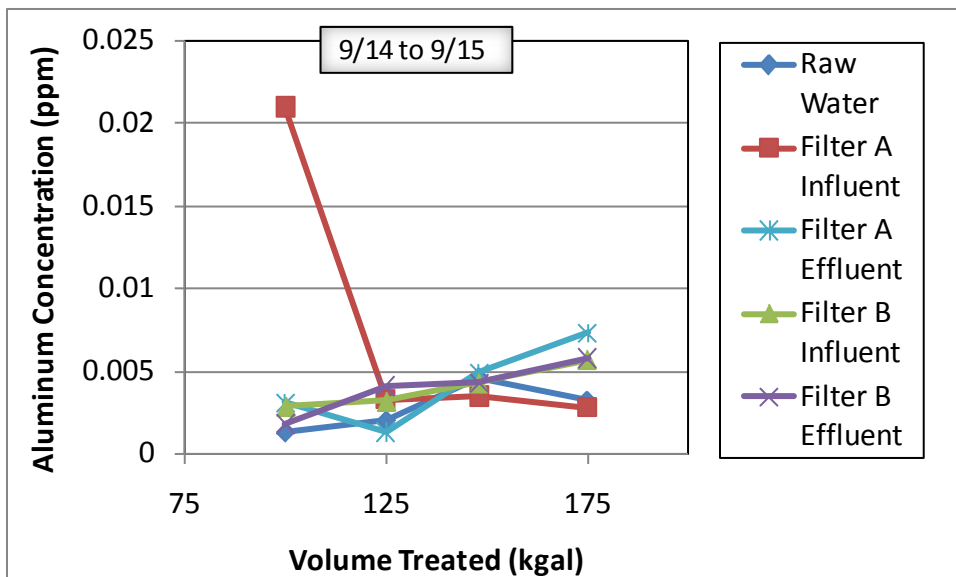
Figure 25: Aluminum Concentrations over Volume of Water Treated for September 14th through 15th with a Ferric Chloride dose of 3.5 mg/L
